UH-1 MATERIEL MALFUNCTION/FAILURE MISHAP EXPERIENCE

1 July 1973 - 31 July 1977

Applied Research Division
Directorate for Technical Research and Applications

DOC 77-07

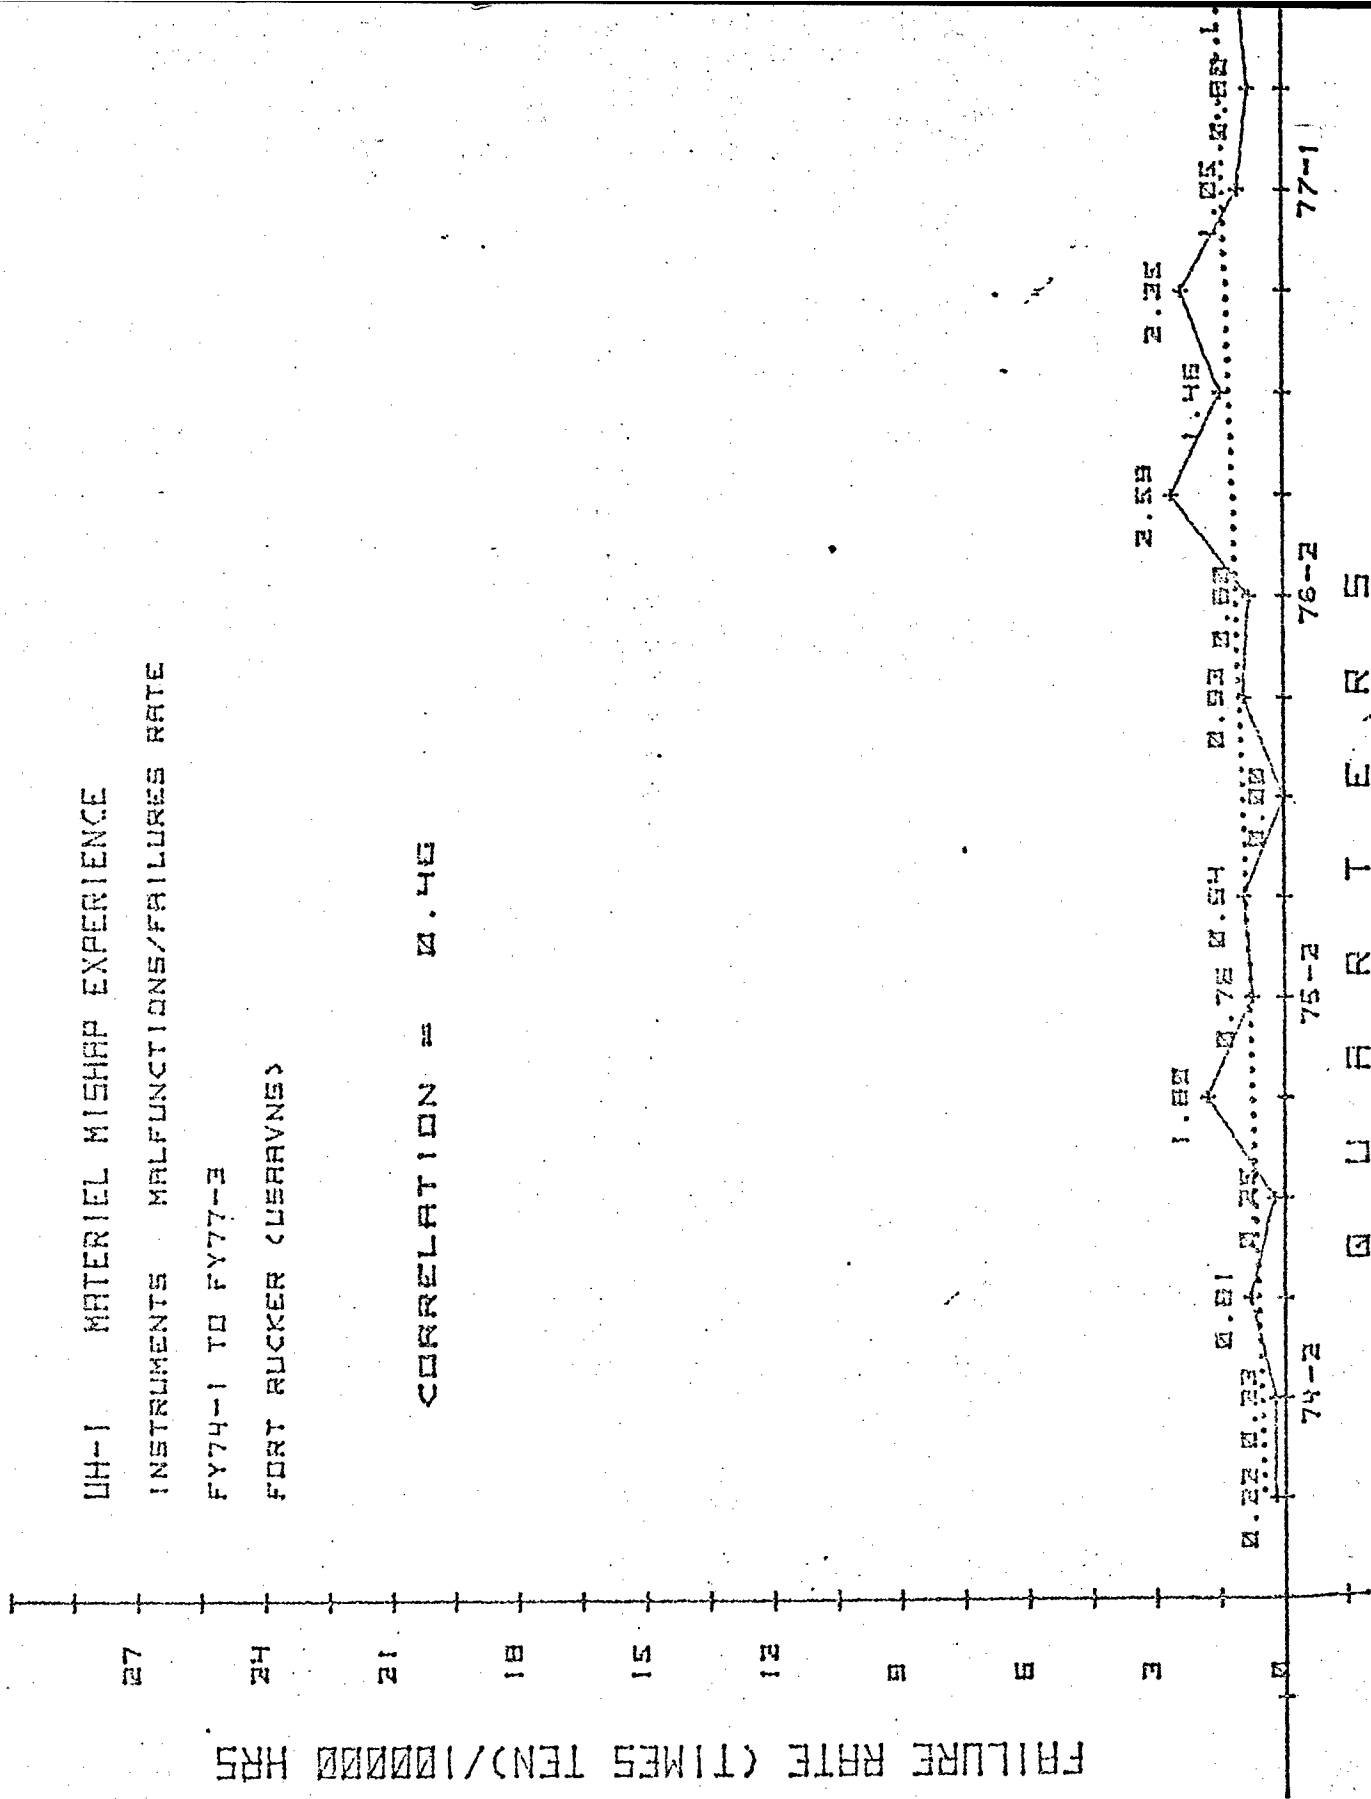
The instrument system malfunctions/failures were the cause of 48 or 6% of the 746 UH-1 materiel caused mishaps. Figure 10 shows an increasing trend. The highest rate, 25.9/100,000 hours, was obtained in 3d quarter FY 76. A zero rate was reached in 3d quarter FY 75.

Instrument materiel caused mishaps for the entire period occurred at a rate of 24.8/100,000 hours.
